Lessons learned from monitoring lighting and daylighting in retrofit projects

T50.D5

A Technical Report of IEA SHC Task 50

IEA SHC Task 50: Advanced Lighting Solutions for Retrofitting Buildings

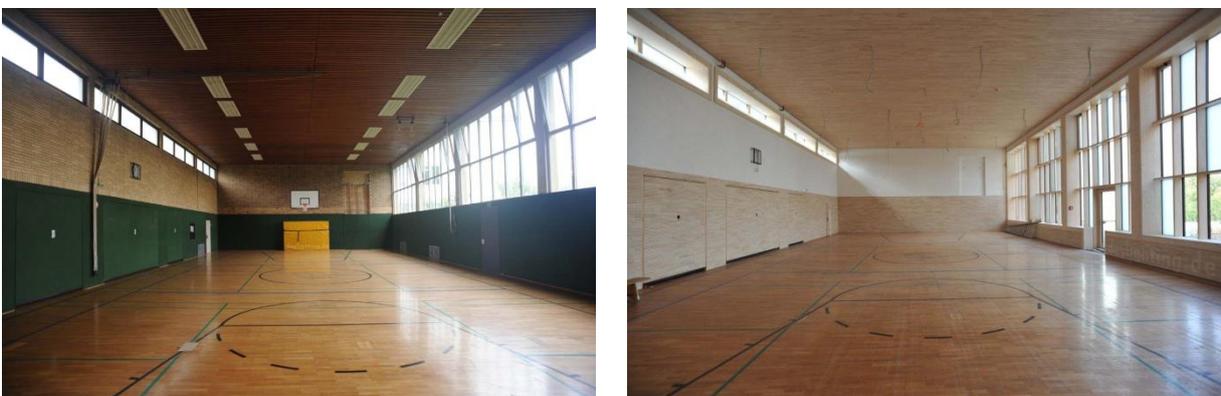
Figure 2: Pre- and post-retrofit of the gym in the vocational college at Detmold

Due to the thickness of the heat insulation layer, the new façade typically has a greater depth compared to the old façade. Especially with small window sizes a greater thickness of the outer wall reduces the transparency of the façade. With a large window dimension this effect is less significant.

However, the change from a double to a triple glazing and increased depth of the construction contribute to reducing the daylight transmission of the facade. When planning a new facade, the existing position and size of the window should not just simply been adopted, but be analyzed and optimized. By using a VIP insulation, a too large total depth of the wall structure can be avoided. The use of large-scale fixed glazing, can be used to reduce the portion of frames and hence optimize light transmission.

The glass area of the overhead window band in the small gym at the vocational college in Detmold was almost halved with the renovation. Here, the insulation of the adjoining flat roof considerably reduced the space available for the construction of the strip-window. Under these circumstances it is considered a success, that the window band could be preserved. Since the lower casing of the window was beveled, for a viewer in the gym the window opening does not appear to be smaller than before the renovation. The windows before renovation typically had uncoated double glazing, while the new windows have a triple low-E glazing.

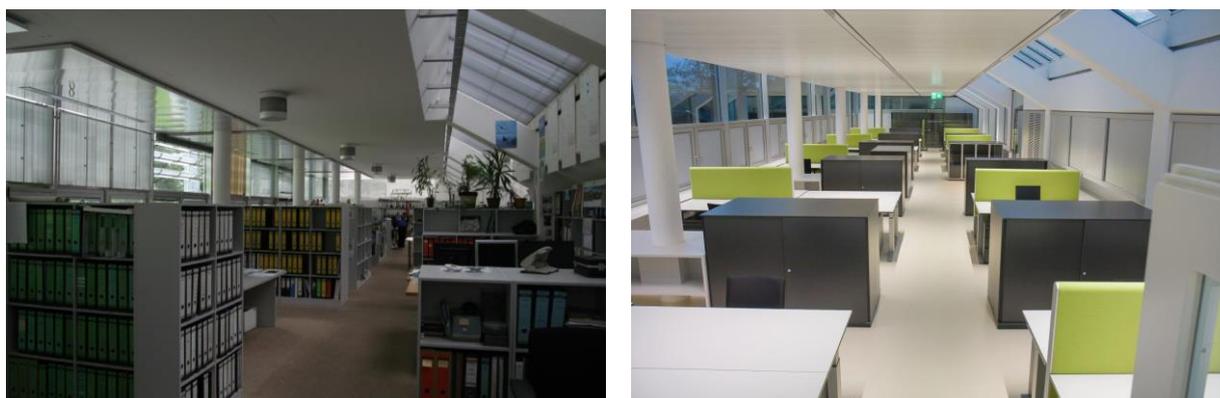
Figure 3: Pre- and post-retrofit of the Bartenbach R&D office in Austria.

Nearly one third of the case studies included measures on the daylighting systems. Measures on daylighting systems were almost always combined with measures on the facade or on skylight systems. Only in one case, the research and development office Bartenbach new external shading systems have been installed in front of an existing facade. The office has a bilateral daylighting strategy. On the south facade adjustable horizontal blinds have been installed, the distance of the lamellas becomes larger upward to optimize daylight penetration. The skylight on the north side of the office has been equipped with a fixed external shade that has been optimized for the local sun path. With this combination, the visual link to the exterior was maximized even for sunny conditions. This design provides abounding daylight to the office space while effectively protecting the interior from overheating.

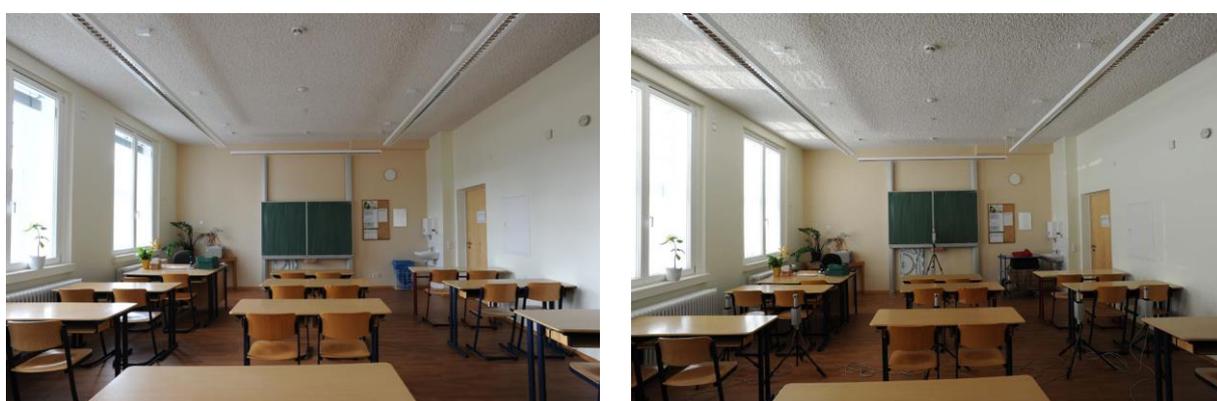
Figure 4: Interior view of Classroom in the Friedrich-Froebel-School under overcast sky (left) and sunny sky with light-directing blinds (right).

Innovative control systems regulate the daylight devices and the electric lighting systems based on comfort and energy efficiency in the building. In the classrooms of the Friedrich-Froebel-School in Olbersdorf such an advanced control strategy was applied. The button "lighting", triggers the activation of controls regarding facade systems and electric lighting. Specifically, this means that compliance with the target illuminance is ensured in the space. This is achieved by the opening of the blinds and adding electric light in case needed. If direct sunlight hits the facade and people are present in the space the louver blinds are moved in a position that no direct sunlight falls into the classroom. Thus, the basic functionality of lighting is delivered, if one activates the button "lighting". Other functions are delivered without intervention of the users. For example if the thermal shading is active the slat angle opens a bit if a person enters to room in order to allow some daylight to penetrate the space.

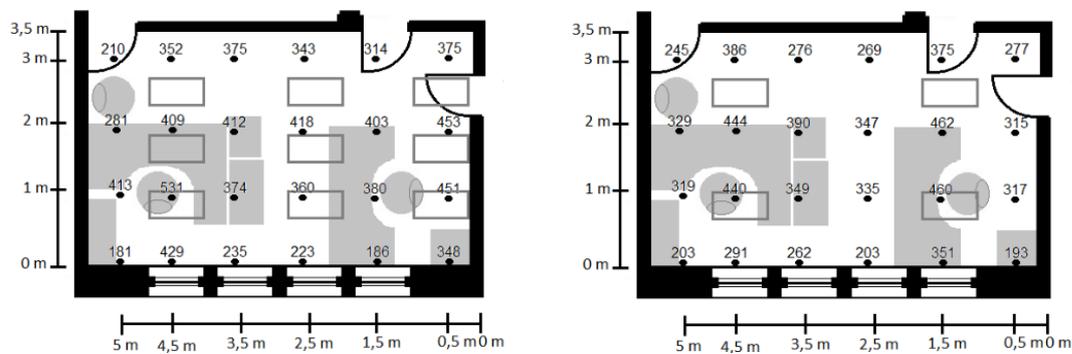
Figure 1: Illuminance distribution from electric lighting system pre- and post-retrofit (right) situations in office s.238 at Horsens Town Hall, Denmark.

At the Horsens Town Hall offices in Denmark, the replacement of the old fluorescent luminaires to LED panels resulted in energy savings, while the illumination was kept as more or less the same. In some offices it was possible with the replacement to reduce the number of luminaires and still keep approximately the same amount of light output. For example at office s.238 (a 2 persons office with a net floor area at approximate 19 m²) it was possible to reduce the amount of luminaires from nine to four while providing the space with a more even distribution and a brighter appearance.
